## Vertebral-subclavian bifurcation treatment. “The wedding ring technique” for a vertebral in-stent restenosis associated with stent fracture

*This report describes a solution for a restenosis and for the fracture of a stent in the vertebral artery in a patient suffering from vertebrobasilar symptoms. Angiography demonstrates restenosis of a vertebral stent as well as its fracture and migration into the subclavian artery. This complication was managed percutaneously by passing a guide wire through the fractured stent. Pre-dilatation and kissing balloon techniques were applied in both the vertebral and subclavian arteries to modify the stent's dimensions and shape it into the form of a “ring.” Postprocedural angiography demonstrated an excellent final result with the assistance of StentBoost visualization. Control angiography at six months also utilized StentBoost imaging and confirmed the patency of the bifurcation and that the stent was not displaced.*

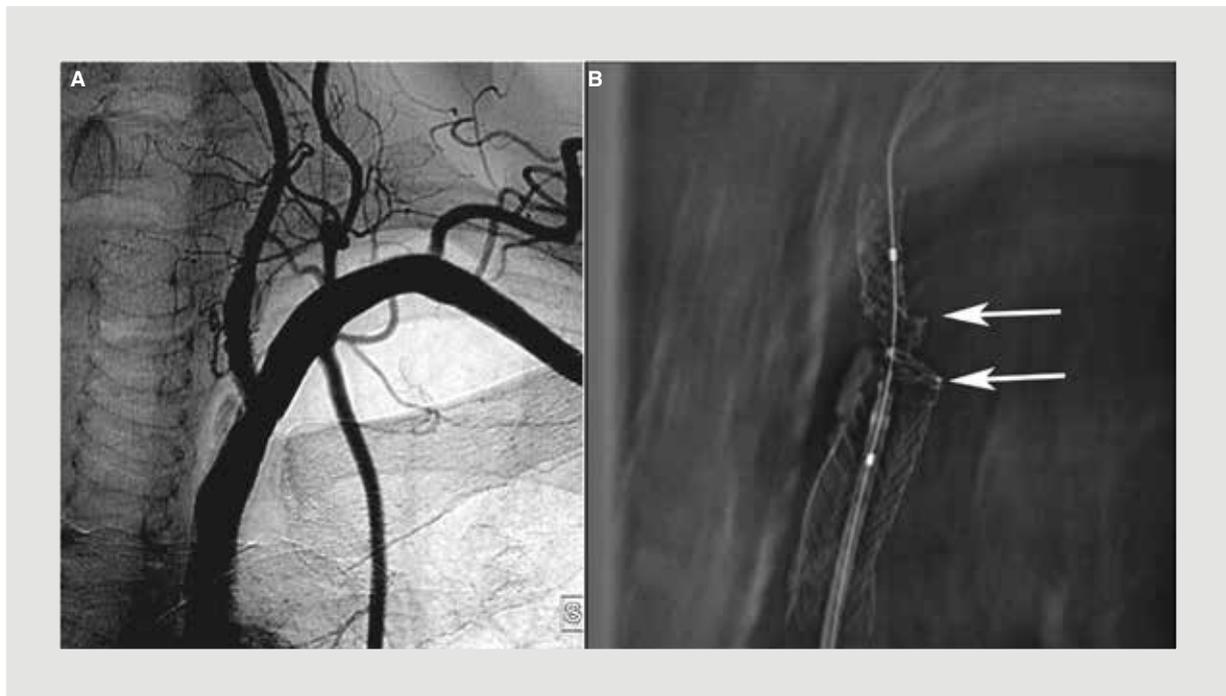
**Figura 3. A:** Angiographic follow-up, with minimal hyperplasia at the subclavian and vertebral stents. **B:** The StentBoost control enhances the modification of the stent struts in the ostial segment of the vertebral artery (upper arrow), as well as the new bifurcation architecture. The ring shape image is preserved (lower arrow).

Initial angiographic images revealed in-stent restenosis within the vertebral artery, as well as the image of a fractured vertebral stent, which had apparently been dislodged into the lumen of the SC artery (Fig. 1). We subsequently placed a 0.0014-inch CholCE™ Extra support guide wire (Boston Scientific Corporation Natick, MA, USA) into both the SC and VA. In the SC artery, the wire was passed through the cells of the fractured stent. An initial kissing balloon and two Sprinter® Legend balloons (2.5 × 20 mm) (Medtronic Inc, Minneapolis, USA), facilitated the advance of a Quantum® balloon (5.0 × 15 mm) (Boston Scientific, MA, USA) through the SC artery, making it possible to use sequential kissing balloons. The fractured stent was then shaped into a thin ring, similar to the shape of a “wedding ring.” The origin of the VA was stented with a Taxus® stent (4.0 × 16 mm) (Boston Scientific, MA, USA). A final kissing balloon was utilized, and the final results of the procedure are depicted in figure 2. Control angiography performed eight months later demonstrated a patent bifurcation, and normal flow within the VA and SC arteries and only minimal intimal hyperplasia. StentBoost imaging revealed preservation of the bifurcation, as well as mild deformity of the ostial segment of the VA (Fig. 3).

depending on the characteristics of the lesion. In the example of the kissing balloon, the use of two stents, as well as the rewiring of a single stent, carries the risk of embolization but may be useful if applied only in special cases. The angiographic follow-up images and StentBoost images demonstrated the durability of this technique. At present, the fractured stent that was lodged in the SC artery remains in both the same form and position, with endothelium having covered its surface. The patient remained asymptomatic as of her six-month follow-up appointment.
